NATO CCMS Pilot Study: Environmental Aspects of Reusing Former Military Lands

Liepaja, Latvia Special Economic Zone Phase II Site Visit and Proposal Evaluation

May 1997

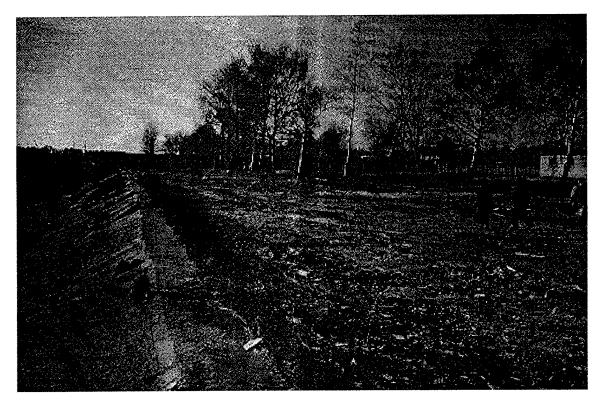
- The former submarine battery reclamation and storage area where lead and other heavy metals have been detected in nearby Liepaja Harbor sediments (Figures 8 & 9).

Not surprisingly, the COWI-Baltec (1996) study observed a high, specific lead contamination in the middle part of the Tosmares Channel, which was attributed to the former battery storage and reclamation area on the northern side of the channel. It appears that the release of heavy metals including lead from sediments, especially those from the highly contaminated Tosmares Channel, has been minimal due to chemical speciation of metals caused by strong anaerobic conditions found in the harbor.

Figure 8 - Lead-acid Battery Storage and Reclamation Area

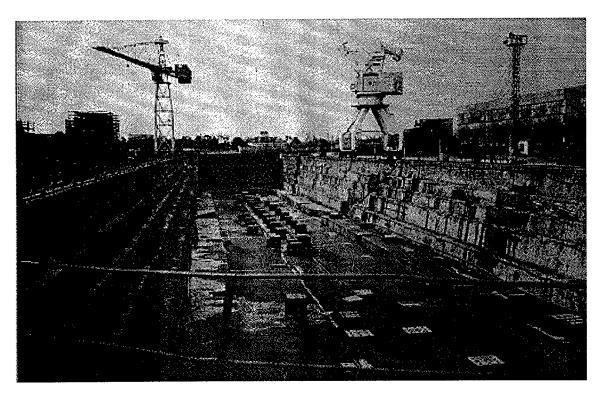
- Two dry-docks where heavy metals from sandblasting residues are expected (Figure 10).
- Air defense missile firing locations where propellant spills are suspected (Figure 11).

Figure 10 - One of Two Working Dry-dock Facilities

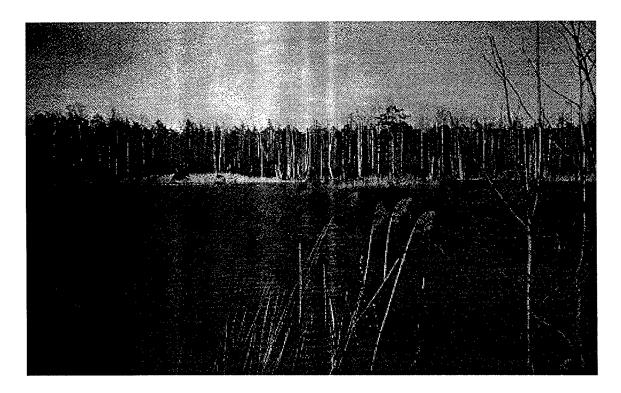
- An extensive array of former ammunition and explosives warehouses, bunkers and other holding structures which may contain explosive materials and debris (Figures 12 & 13).

used to store ordnance, particularly in the northern region of Karosta, are likely to be contaminated with unexploded ordnance (UXO), explosive materials, and hazardous debris.

Figure 13 - Fire Suppression Water Storage Pond and Suspected Ordnance Dump

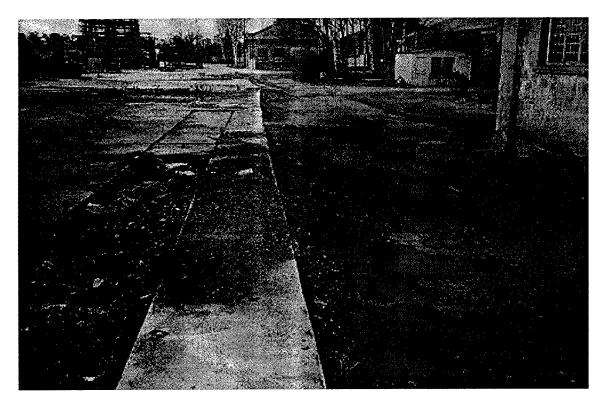
- Miscellaneous sites throughout the Karosta and Liepaja Harbor, particularly near industrial shops, fuel storage and transfer facilities, railroad lines, scrap yards, and piers suggesting the presence of petroleum hydrocarbons, solvents and heavy metals (Figures 14-17).

Figure 14 - Typical Stained Site in Industrial Area

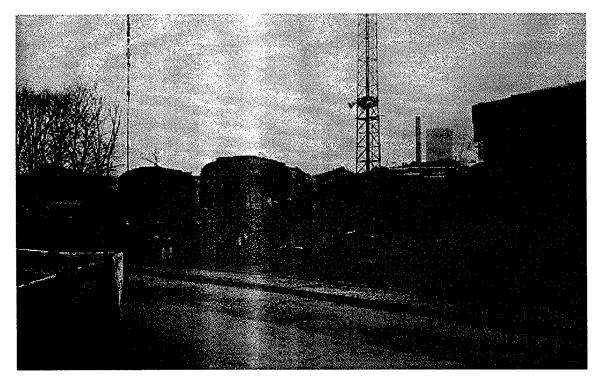
Figure 17 - Rail Transportation Salvage Yard
